# Oxspring Lodge:

## reconstructing a Yorkshire hunting lodge

By P. F. RYDER

**SUMMARY:** *A mid sixteenth-century hunting lodge of the Bosville family, which survive intact until the late nineteenth century, is now reduced to its footings. Using an unpublished description and photographs taken early this century, the lodge can be reconstructed on paper showing it to have been of unusual hybrid construction using stone external walls along with a internal timber frame; some similar sixteenth-century structures survive in the area. The building also demonstrates a fusion of 'Highland' and 'Lowland' traditions in carpentry, and in addition provides an interesting example of what are usually thought of as vernacular building techniques in a high-status structure.*

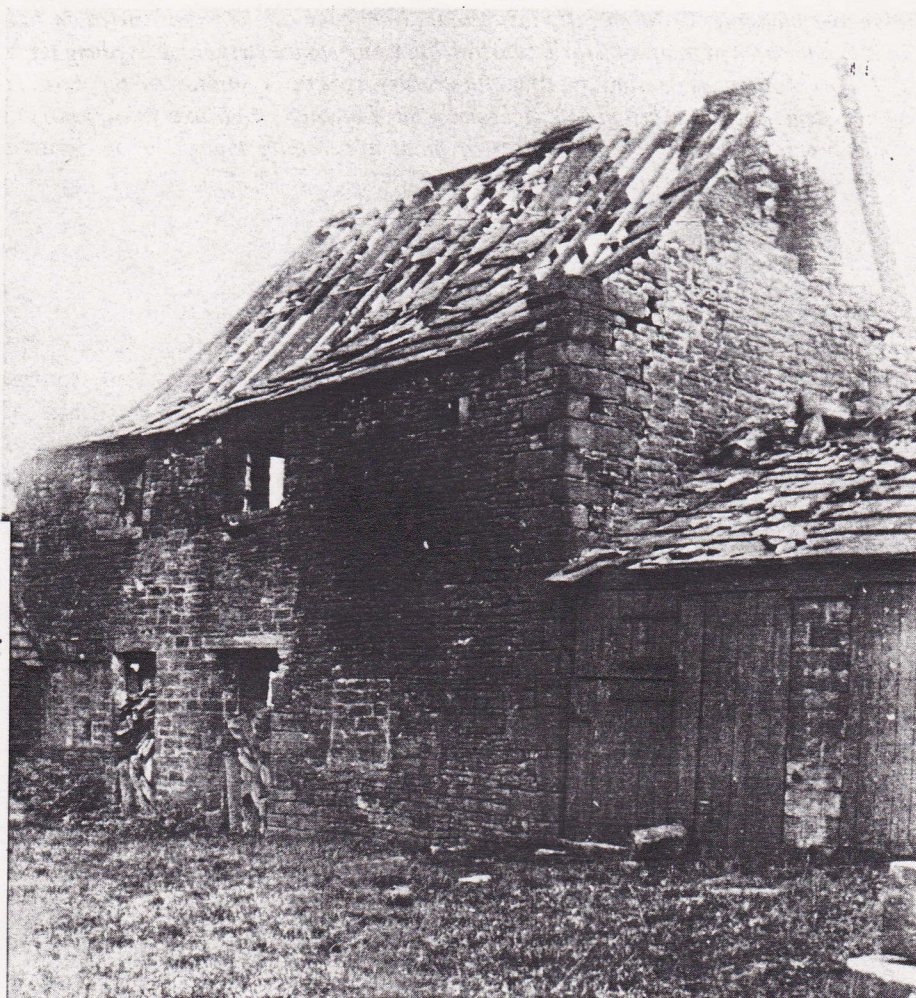
FIG. 1

The Lodge from the south east (C. F. Innocent, c.1910)

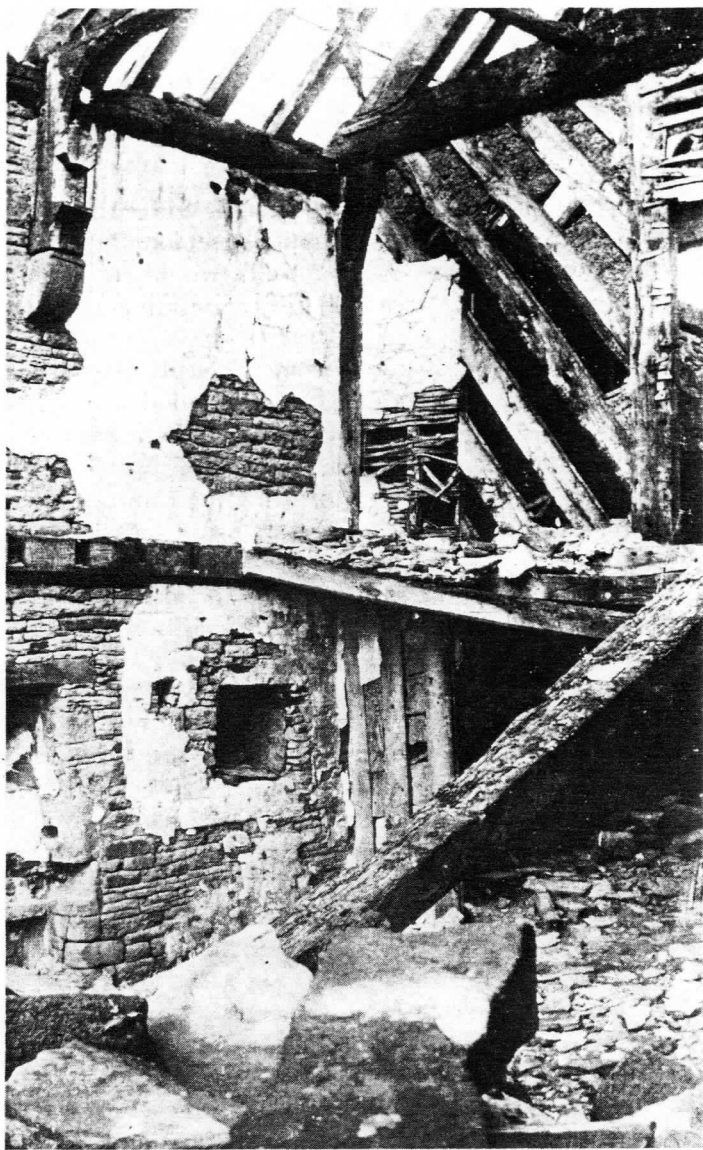
FIG. 2

Interior of west bay looking north-east (C. F. Innocent, *c.*1910)
